WOOD DESTROYING PESTS AND ORGANISMS INSPECTION REPORT

Building No. 9504 Lefty Ln., Rightway City, CA 90009	Street	City	Zip	Date of Inspection 01/01/2006	Number of Pages 5
--	--------	------	-----	----------------------------------	----------------------

Your Pest Company Inc.
 234 Your Street, City, CA. 90000
 (800) Your Number - www.yourcompany.com

Report # W20934
Lic. Registration # PR 9999
Escrow # 064919-AC

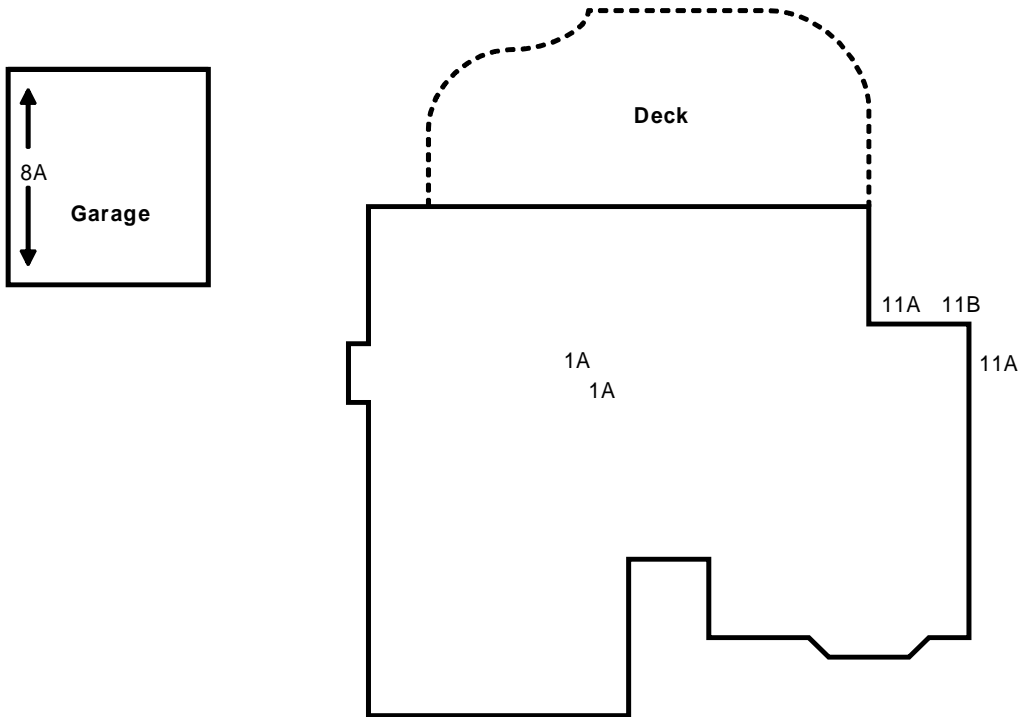
This Diagram is not to scale

FINDINGS: Evidence of subterranean termite infestation at sub area under main bath.

FINDINGS: Evidence of drywood termite infestations at garage framing.

FINDINGS: Evidence of drywood termite infestations at exterior window trim.

FINDINGS: Evidence of termite damaged wood members noted at time of inspection at 2 x 8 fascia board.

RECOMMENDATION: Treat soil with Termidor termicide by slab injection and/or trench application for the control of subterranean termites infestations as noted on the diagram. Remove accessible subterranean termite tunnel tubes.

RECOMMENDATION: Drill and inject termicide solution into visible and accessible infested wood members. Remove or cover accessible pellets.

RECOMMENDATION: Replace termite damaged wood members and/or repair non-structural damaged wood members with construction grade materials. No painting is included in this estimate.
